# CORNER RECORD

Agency Index CR-22-033

City of Stockton County of San Joaquin, California

Brief Legal Description Found monument as noted, referenced and left as found.

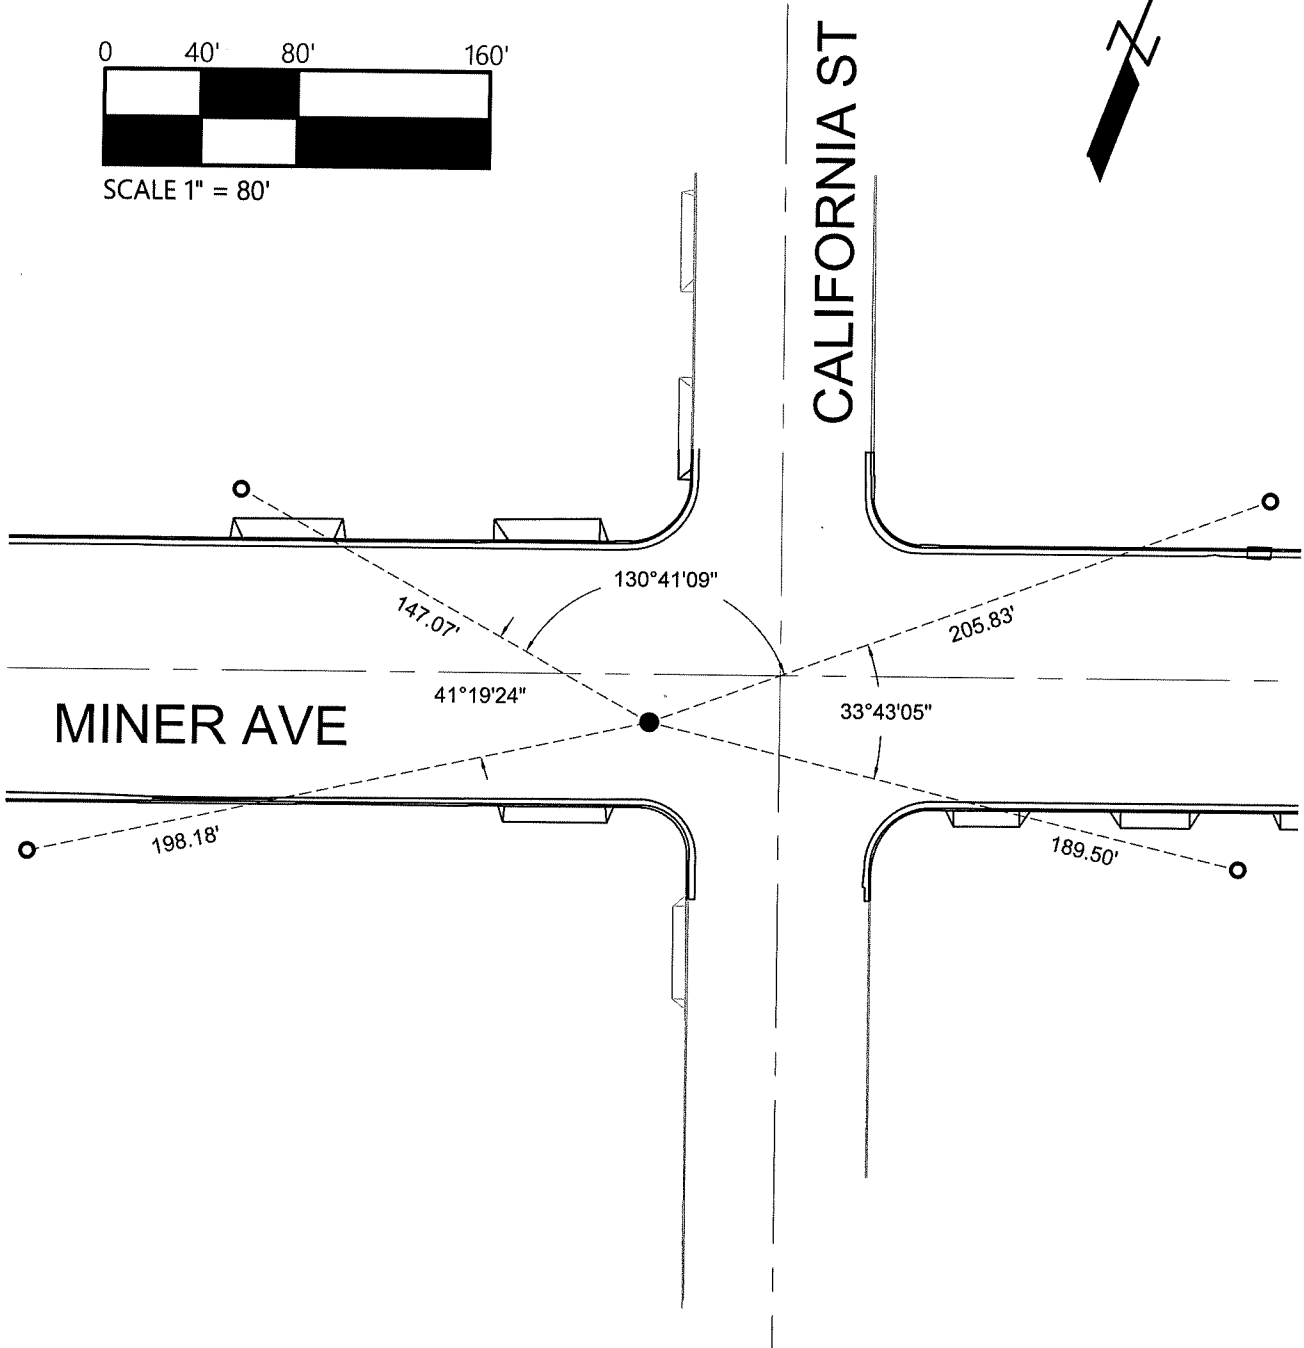
Found a 3/4" Iron Pin, no tag, in monument well at the intersection of Miner Ave and California St. Set four (4) reference points, as noted on the reverse, outside of the construction limits.
