CORNER RECORD

Agency Index CR-24-120
Document Number _____

City of STOCKTON County of SAN JOAQUIN, California

Brief Legal Description FOUND MONUMENT SHOWN IN BOOK 27 OF MAPS AND PLATS PAGE 74.

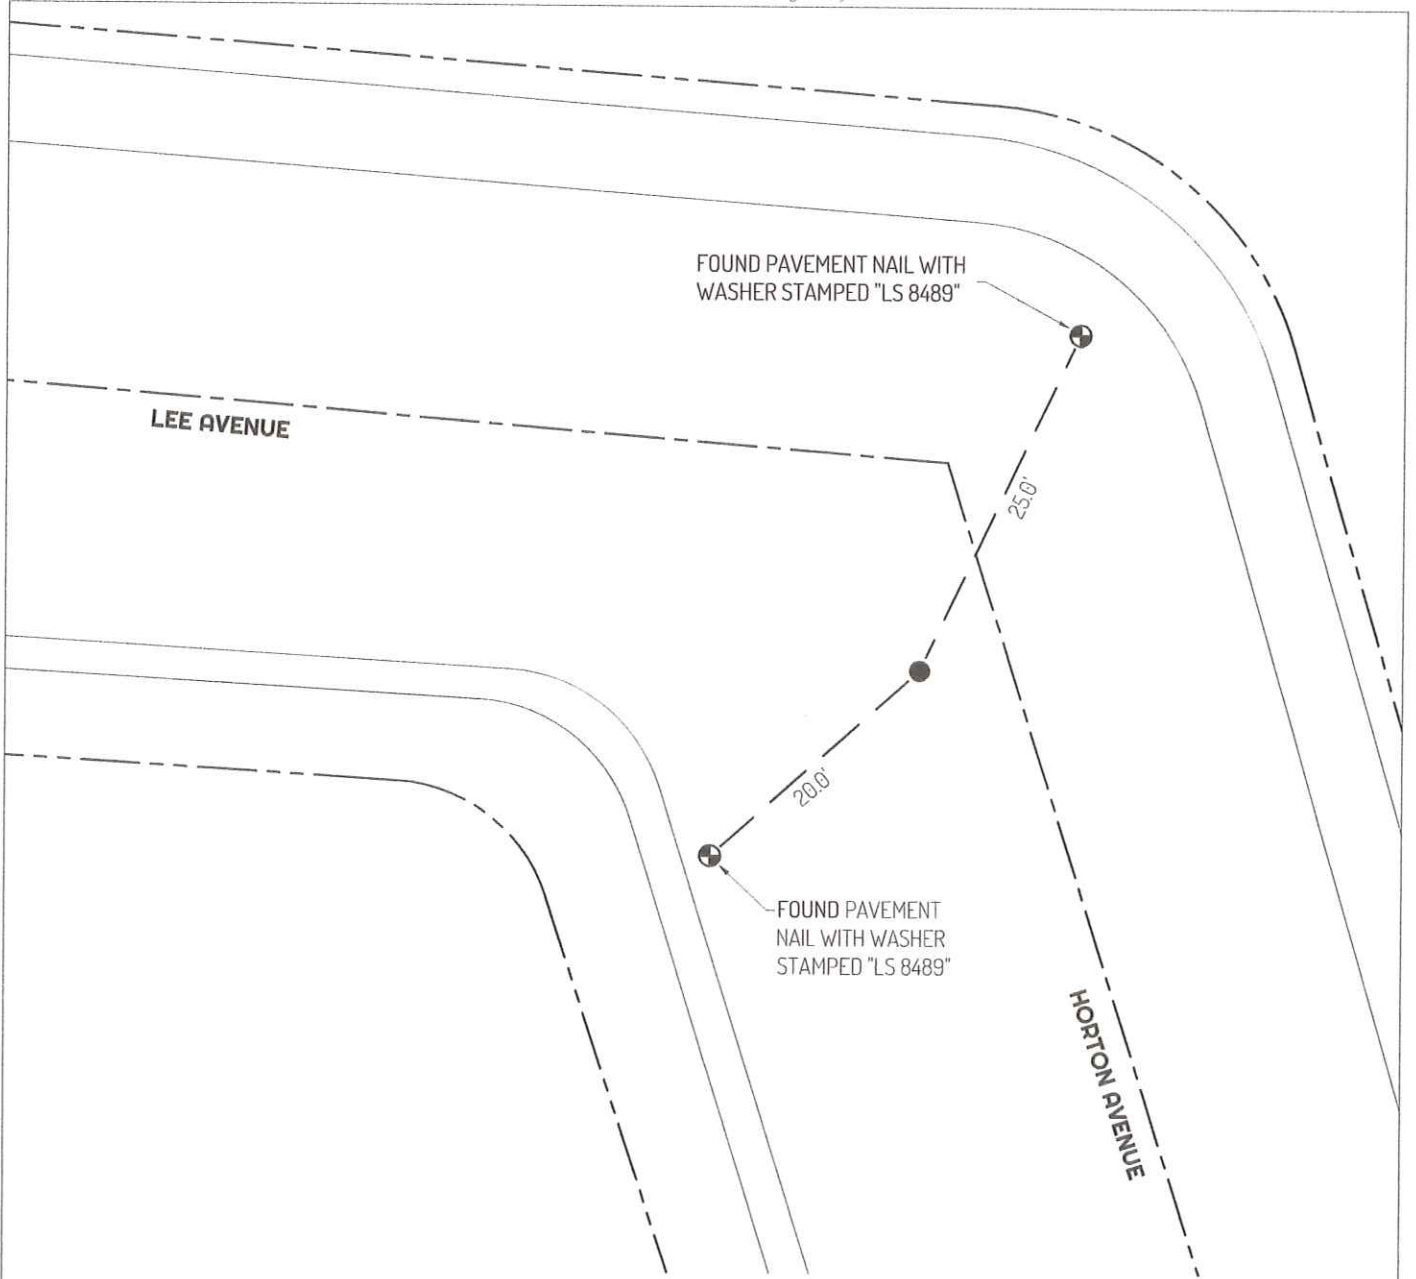
- FOUND 3/4" IRON ROD IN CENTERLINE WELL (A) NO CAP OR TAG
- ⊕ FOUND CONTROL POINT
- 955 ASSESSOR'S PARCEL NUMBER
- MP MAPS AND PLATS, SAN JOAQUIN COUNTY RECORDS

(A) MP 27-074 AND CORNER RECORD 22-266, SAN JOAQUIN COUNTY SURVEYOR'S RECORDS
